Confidential Inspection Report

456 Main St

Mesa, AZ 85210

Report: 0000054 Address: 456 Main St

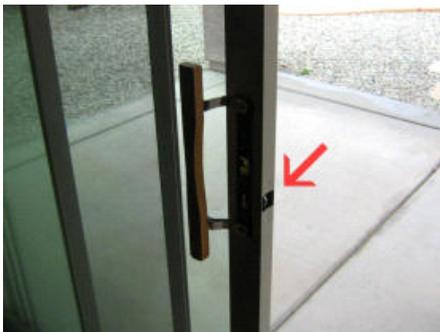
2.11 Patio Door & Condition

Action Necessary - The sliding glass door latch does not work. Door adjustments should be left to a professional because of the pool. I recommend corrections as necessary to repair proper operation of the door latch for safety.

Attention Needed - Screen door is damaged, replace door.

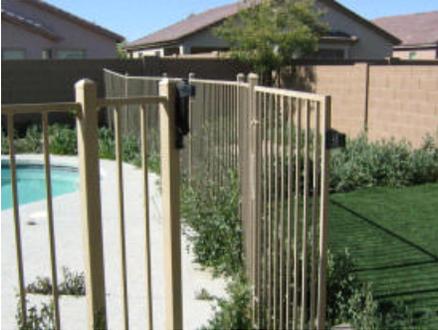
2.15 Fence Needed - Pool/Spa Area

Action Necessary - The pool gate latch is not latching properly, it is required to be self closing and self latching. I recommend repairs to the latch for child safety.

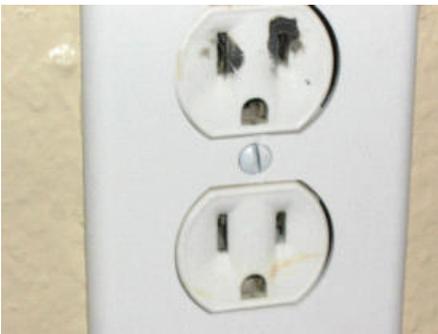
5.19 Electrical Outlets

Action Necessary - One outlet shows that it has arced and is unsafe to continue using, I recommend having a Licensed Electrician further evaluate the system and replace outlet.

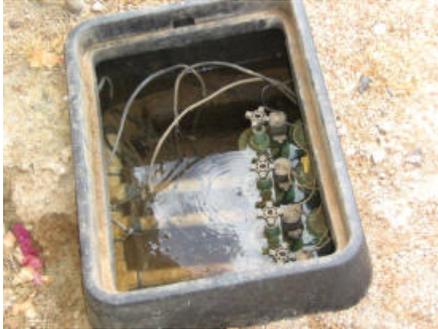
Attention Needed - Sprinkler valve(s) were observed leaking at ease side of house. Make repairs as needed to stop wasting water. The inspection of the installed lawn sprinkler system is limited to observation of the above ground portion of the system, valves(s) and piping. The system wasn't operated and is beyond the scope of a home inspection,

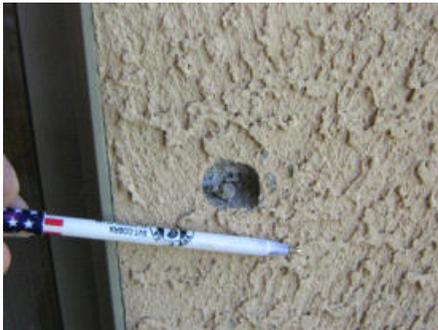
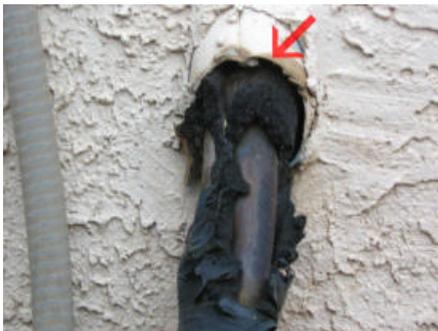
Structural:
4.3 Siding Condition:

Attention Needed - Holes/cracks/opening are evident in the exterior siding at the AC lines a hole in back. This condition may allow water and bugs to enter behind the siding and possibly cause damage to the sheathing or structural framing, sealing is needed.

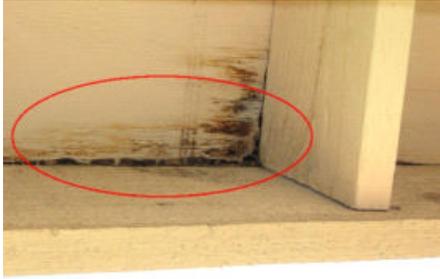
4.5 Soffit/Eaves:

Attention Needed - Patio soffit/eaves has dry rot and water stains from roof leak above (see Roofing) and needs minor repair to prevent further deterioration.

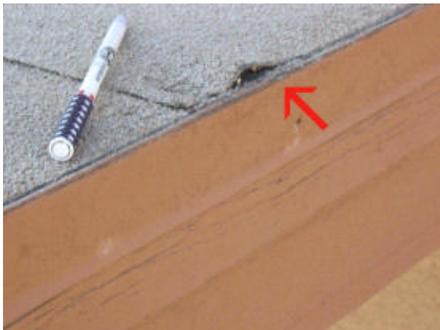
7.4 Condition of Patio Roof Material;

Attention Needed - I observed openings at the edges of the rolled roofing material over the patio. Potential for water entry and damages exists. I recommend sealing at all drip edge flashings, seams and openings as needed.

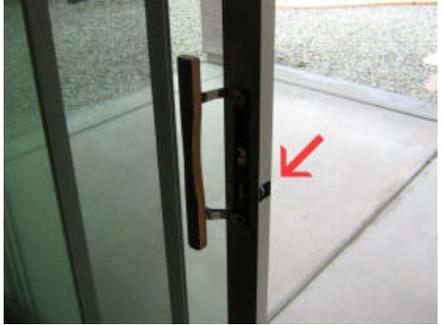
- 2.9 *Patio Slab Materials:* Concrete.
- 2.10 *Slab Condition:* Satisfactory - The slab is in useable condition. With common cracks, which is typical for this type of surface. This does not have a significant effect on the functionality of the patio. As long as the floor is adequately thick and properly supported with a gravel base it will last for decades.
- 2.11 *Patio Door & Condition* **Action Necessary** - The sliding glass door latch does not work. Door adjustments should be left to a professional because of the pool. I recommend corrections as necessary to repair proper operation of the door latch for safety.

**Attention Needed** - Screen door is damaged, replace door.
- 2.12 *Columns:* Wood post(s), Satisfactory - The post(s) are performing as intended.

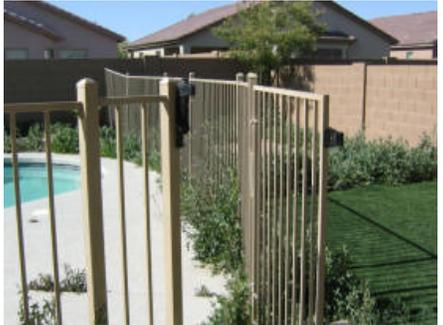
- 2.13 *Fencing Materials:* Concrete Block.
- 2.14 *Fence Materials Condition:* Satisfactory - The yard fencing materials appear to be in satisfactory condition.
- 2.15 *Fence Needed - Pool/Spa Area* **Action Necessary** - The pool gate latch is not latching properly, it is required to be self closing and self latching. I recommend repairs to the latch for child safety.

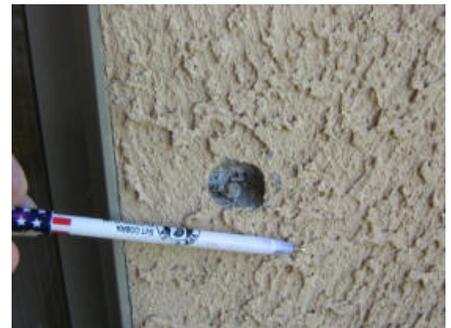
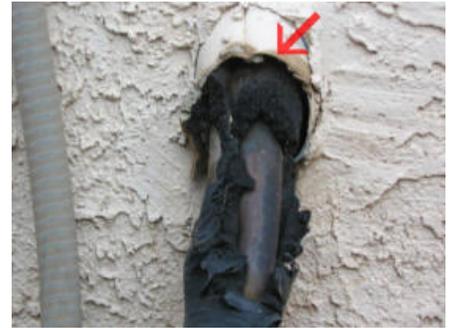
Attention Needed -

Holes/cracks/opening are evident in the exterior siding at the AC lines a a hole in back. This condition may allow water and bugs to enter behind the siding and possibly cause damage to the sheathing or structural framing, sealing is needed.

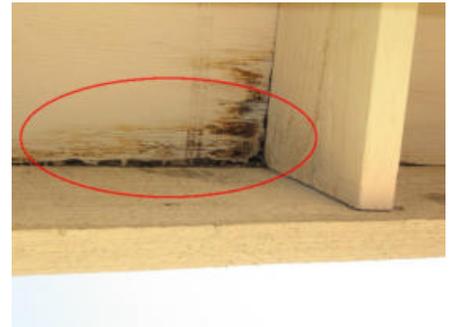
4.5 Soffit/Eaves:

Attention Needed - Patio soffit/eaves has dry rot and water stains from roof leak above (see Roofing) and needs minor repair to prevent further deterioration.

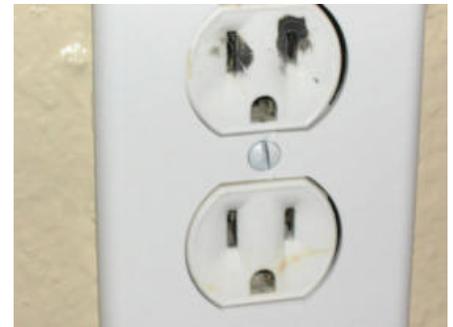
Electrical Outlet

- 5.19 *Electrical Outlets* **Action Necessary** - One outlet shows that it has arced and is unsafe to continue using, I recommend having a Licensed Electrician further evaluate the system and replace outlet.

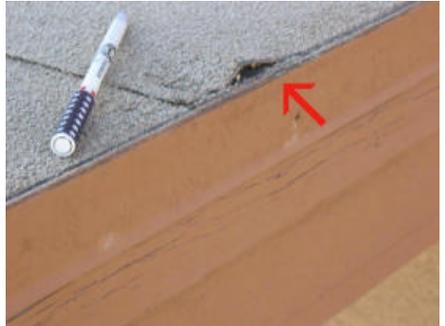
- 7.3 *Condition of Main Roof Material:* NO crack or missing tiles were found today, every few years tile roofs should be inspected for damage.
- 7.4 *Condition of Patio Roof Material:* **Attention Needed** - I observed openings at the edges of the rolled roofing material over the patio. Potential for water entry and damages exists. I recommend sealing at all drip edge flashings, seams and openings as needed.
