Confidential Inspection Report

456 Main St

Mesa, AZ 85210

Report: 0000054 Address: 456 Main St

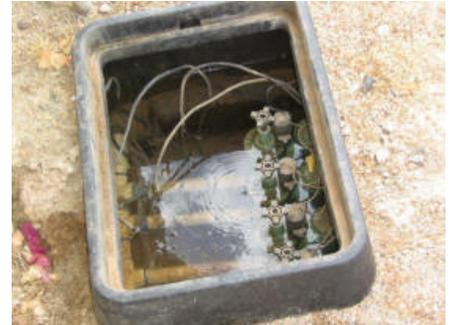
Attention Needed - Sprinkler valve(s) were observed leaking at ease side of house. Make repairs as needed to stop wasting water. The inspection of the installed lawn sprinkler system is limited to observation of the above ground portion of the system, valves(s) and piping. The system wasn't operated and is beyond the scope of a home inspection,

- 2.1 Site Drainage:* Satisfactory - The lot appears to have adequate drainage to prevent water from ponding next to house.
- 2.2 Bushes and Shrubs Condition:* Good - The shrubs and/or bushes have a better appearance than expected. They are neatly trimmed and spaced.
- 2.3 Lawn Sprinkler System:* **Attention Needed** - Sprinkler valve(s) were observed leaking at ease side of house. Make repairs as needed to stop wasting water. The inspection of the installed lawn sprinkler system is limited to observation of the above ground portion of the system, valves(s) and piping. The system wasn't operated and is beyond the scope of a home inspection,

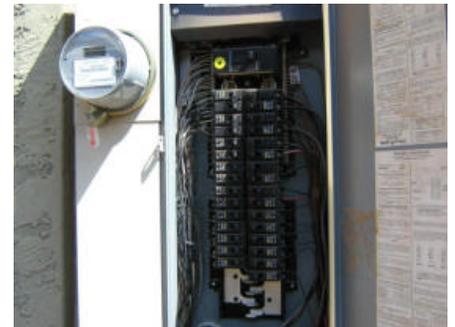
- 5.10 *Condition of Wiring in Panel:* Satisfactory - Electrical circuitry wiring in the panel appears neatly arranged with no unallowable splices.

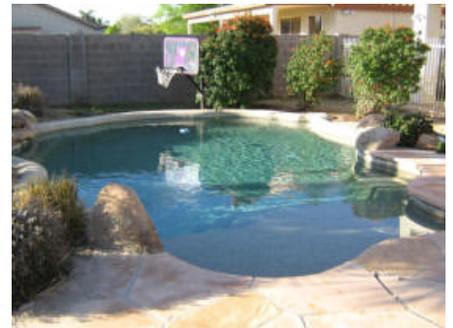
6.1 Pool Type:

In Ground.

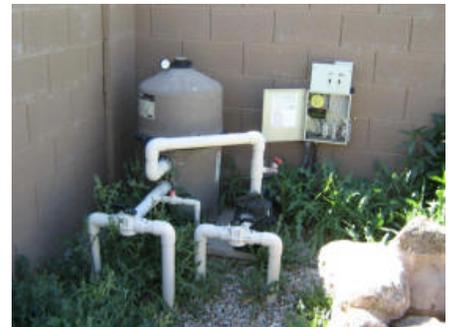
6.12 Pump and Motor Condition:

Satisfactory.

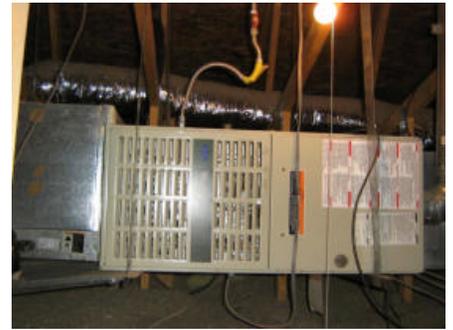
10.21 Gas-fired Appliance Flue/Vents:

Satisfactory - The visible portions of the flue/vent system appear to be installed correctly and appear to be functional.

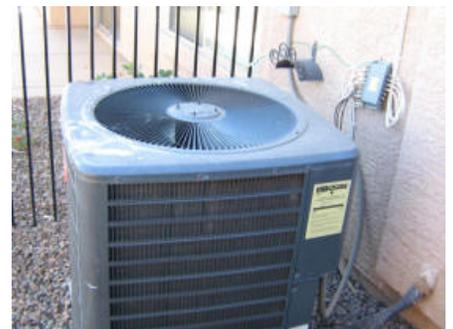
10.26 Air Conditioning Unit(s)

This unit(s) were manufactured about 2005 The AC unit(s) size is: 5 Ton.

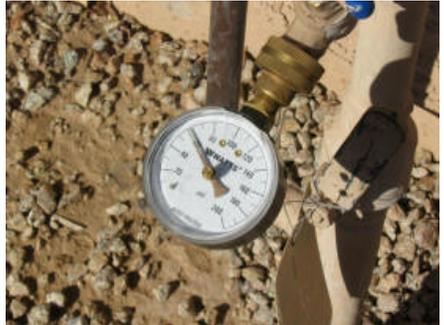
- 11.5 *Water Piping Condition:* Satisfactory - The visible water supply piping is installed correctly and appears to be in satisfactory condition.
- 11.6 *Water Pressure:* City water pressure is at time of inspection at main hose bib 50.PSI.
